**Second  
International Conference  
on  
Case Histories in  
Geotechnical Engineering**

**June 1-5, 1988**

**University of Missouri-Rolla  
Rolla, Missouri**

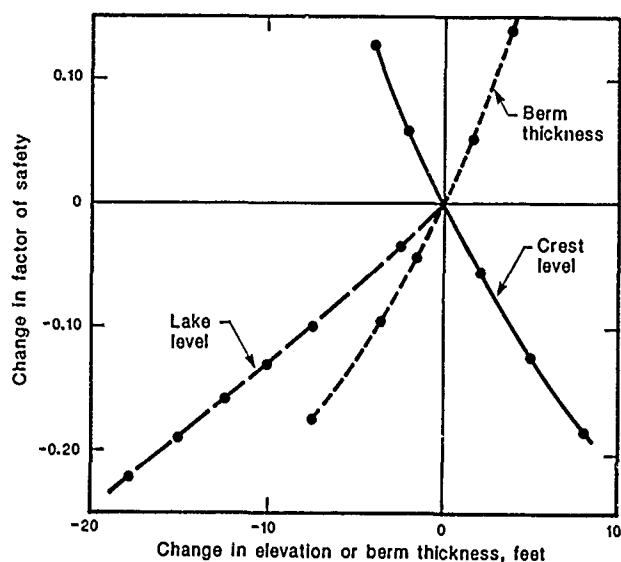
Figure 5. Effect of Various Parameters on Calculated Factor of Safety.

The effect of future changes in lake level, elevation of the crest, and erosion of the berms on Factor of Safety for Sta. 3550 were evaluated in a series of parameter studies. The results are shown on Figure 5 as change in Factor of Safety for each variable alone, the others being held constant at the 1984 conditions.

Changes in lake level were found to have about half of the effect on Factor of Safety as changes in either crest elevation or berm thickness. The direction of each effect is obvious. The Factors of Safety for two of the future conditions are included in Table II.

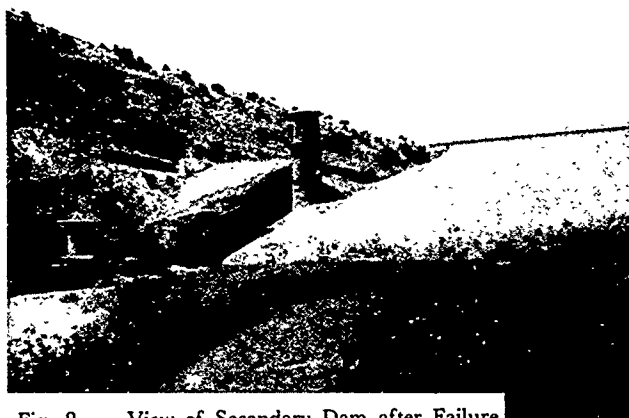
Fig. 2 - View of Secondary Dam after Failure

The upstream portion of the Project was formed mainly by the Main Dam and the Secondary Dam some 10 km farther downstream which were built from 1969 to 1972. The first filling started in May 1972 but the reservoir levels very seldom exceeded a third of the head and never reached the normal water level (NWL) at either dam. On 21 December 1977, the Secondary Dam failed with a water level well below NWL but fortunately major damage was avoided by a rather slow rate of retrogressive erosion of the embankment (about 6 hours) and by the relatively moderated volume of water stored, some  $3.5 \times 10^6 \text{ m}^3$  (Fig. 2).

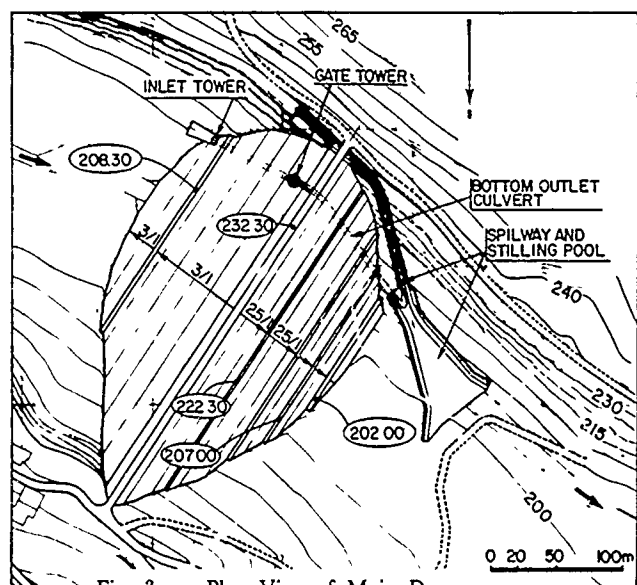
Fig. 3 - Plan View of Main Dam

Both dams are homogeneous embankments with similar design characteristics and similar appurtenant works. Fig. 3 and 4 show the plan view of both dams.

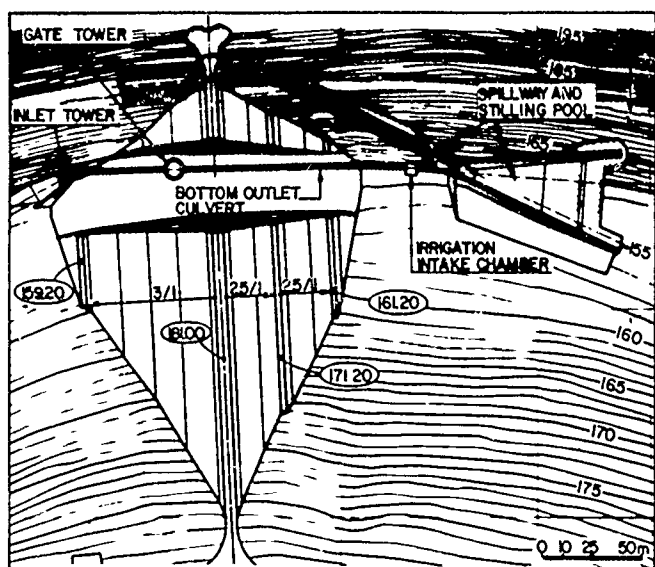
Fig. 4 - Plan View of Secondary Dam after Failure

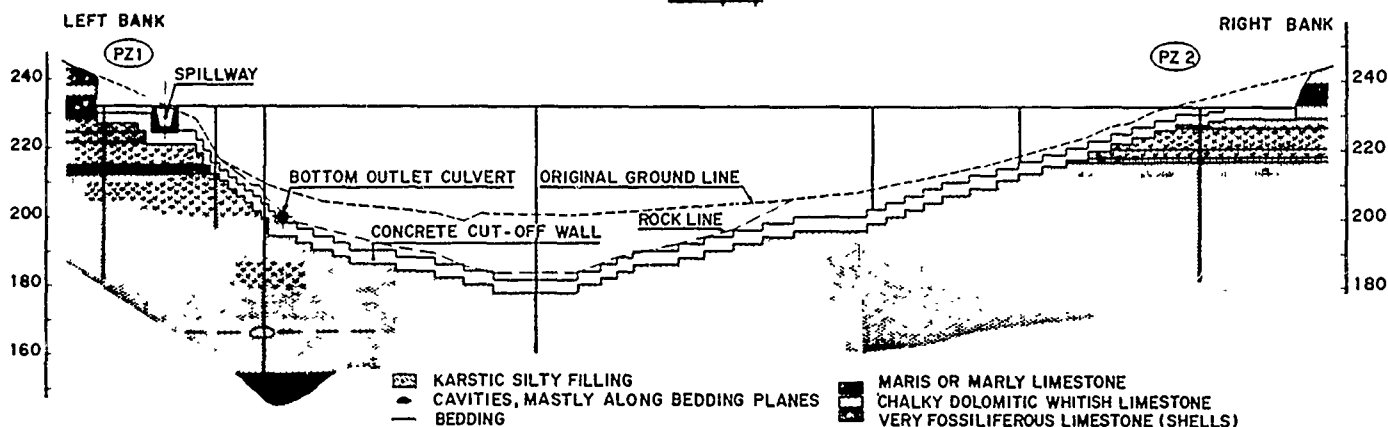
Fig. 6 - Longitudinal Cross-Section of Main Dam

The condition of placing earthfill around the bottom outlet culvert has also to be mentioned. Both faces of the excavated trench in which the conduit lies are only 1 m from the concrete, which does not allow proper compaction of the backfill even by small hand-operated machines. This applies to the downstream portion of Main Dam culvert (Fig. 6).

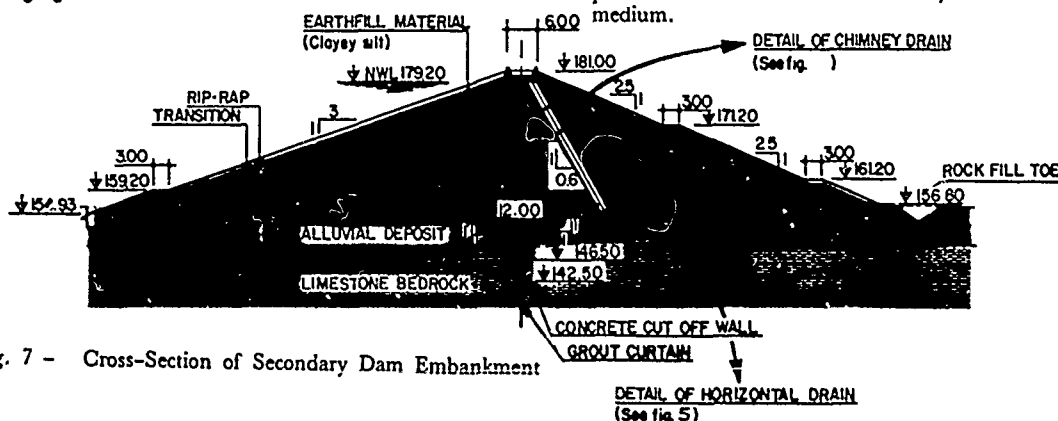
Fig. 7 - Cross-Section of Secondary Dam Embankment

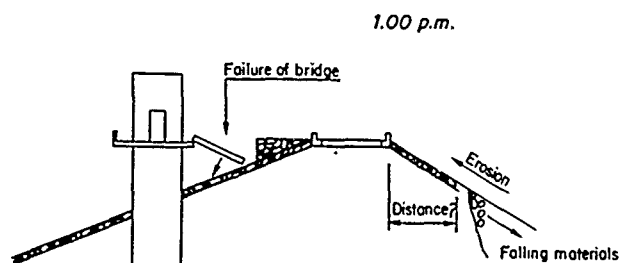
Fig.11 - Sequence of failure at Secondary Dam (1.00 p.m.)

At about 1 p.m., the service bridge between the crest of the dam and the gate tower fell down (see Fig. 11) and ten minutes later the retrogressive erosion broke through this crest, opening a breach to the reservoir; It took until 17 hours for the complete emptying, while the breach was widening and deepening; at no time, vortices or eddies were observed on the water surface in the reservoir.

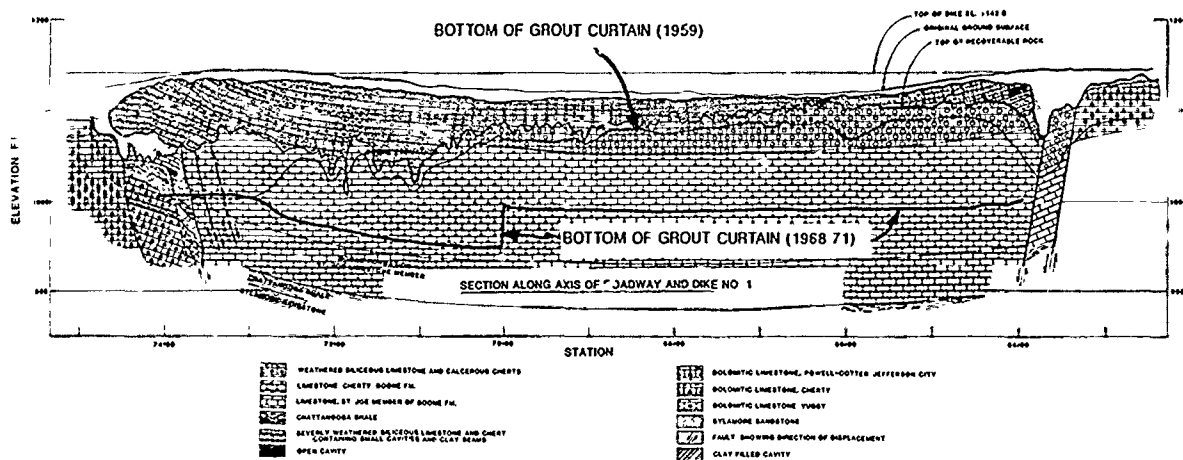
Figure 2. Foundation materials underlying Dike 1

Figure 2 shows the foundation materials underlying Dike 1. Dike 1 is founded on a downfaulted block of the Boone formation. This downfaulted block (graben) extends approximately between station 63+00 at the northern end to approximate station 75+00 at the southern end, a total distance of approximately 1,200 ft. The graben is bounded by steeply dipping normal faults on either side trending roughly in a northeast-southwest direction. The vertical displacement of these faults is approximately 200 ft. Cores of the rock adjacent to the northern fault zone show evidence of fracturing; however, the fractures appear to be filled or cemented and sound. Boring information from the southern fault zone area indicates the presence of many clay-filled cavities. The southern fault gouge does not appear to have the same degree of soundness as the northern fault zone. The Boone Chert which makes up the foundation of Dike 1 can be divided into two distinct sub-units. The upper sub-unit of the Boone Chert (estimated thickness, 100 ft) is composed of calcium carbonate and chert which upon weathering has resulted in the removal of calcium carbonate and left a spongy, vuggy, residual material that is predominately chert. The lower sub-unit of the Boone Chert (estimated thickness, 60 ft) is also composed of calcium carbonate and silica; however, this sub-unit is characterized as being slightly weathered to unweathered and contains more crystalline calcium

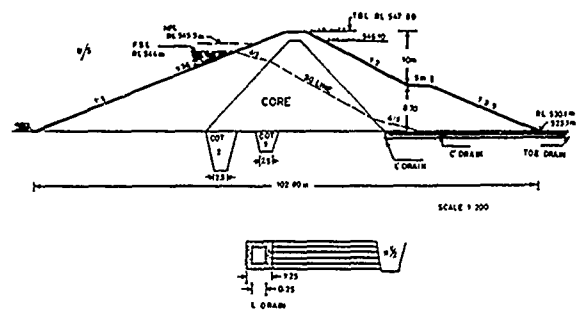
Fig. 3 Cross Section of the Zoned Dam.

The dam is a zoned rolled filled earth dam. The salient features of the dam are given below. See Fig.2 and 3.

The dam lies between : ch 36 and ch 113  
Deepest portion of the  
gorge lies between : ch 70 and ch 75  
Upstream slope : 1:3 upto RL 537.8; 1:2.5  
from RL 537.8 to TBL  
Down stream slope : 1:2.5 between RL 530.10  
and RL 537.8; 1:2 bet-  
ween RL 537.8 and  
RL 547.8

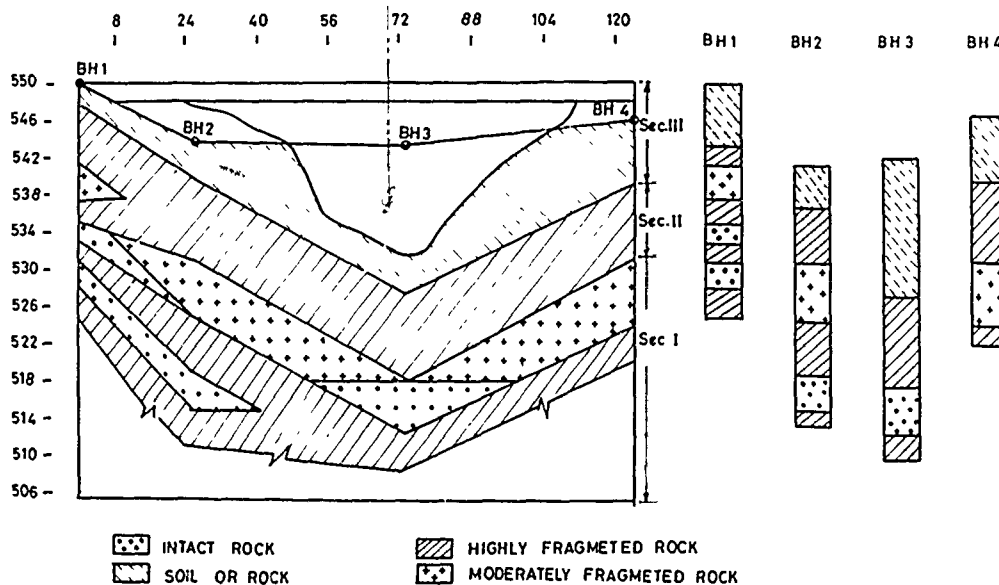
**Fig. 2 Subsurface Section Along the Dam Axis**

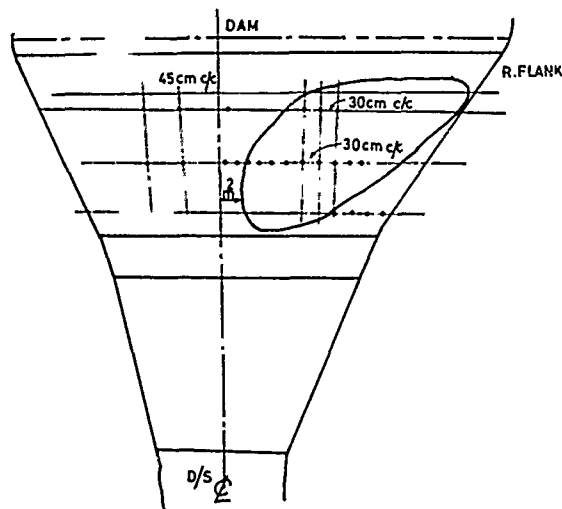
Fig. 7 d/s Face

on the d/s side, there was a need to take immediate rectification measures. The measures taken with respect to stability are described below. With the help of zone of subsidence and heave a probable circular potential plane of failure was adopted for analysis. The computed value of the activating force turns out to be 4 tonnes/m. width. It was considered prudent to provide shear connectors to take the whole activating force (4T/m. width) as the portion was already in the process of sliding. The method adopted consisted of providing 3 rows of shear connectors with the spacing as shown in Fig.7 and Fig.8.

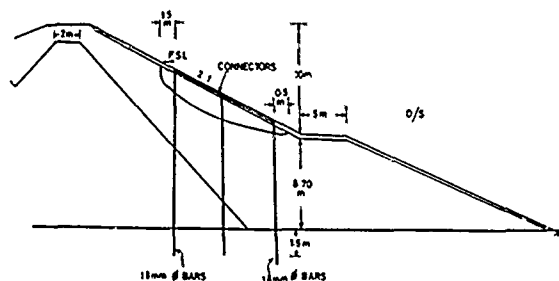
Fig. 8 d/s Section

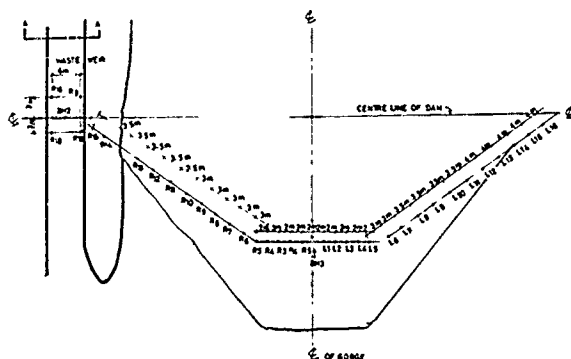
As the pressure due to water is around  $1.5 \text{ kg/cm}^2$  it was necessary to use a thick mix 1:6 to 1:8. The cement bentonite ratio was 60%:40%. The grout mix was injected at  $2 \text{ kg/cm}^2$  and was raised up 4.5 to  $6 \text{ kg/cm}^2$  before termination between RL 505 and RL 520. See Fig.9.

Fig. 9 Grouting Plan.

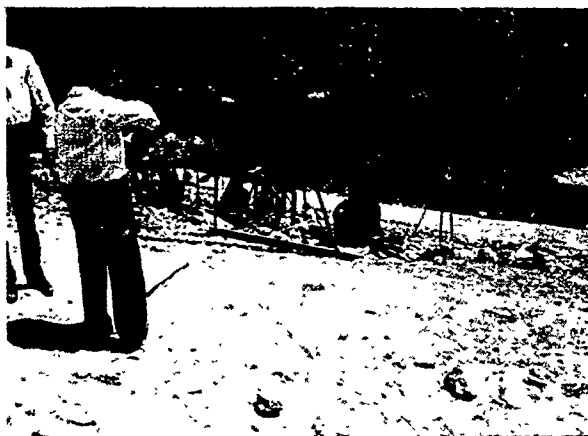
Fig. 10 View Showing Basin Asphaltic Treatment and Grouting.

considerably in reducing the percolation as observed during the filling of the dam. See Fig.10. When the dam was completely filled suddenly a pipe appeared increasing the percolation. Subsequently it was observed that the pipe got started on the upper reaches of one of the stream. See Fig.10. With the help of asphaltic treatment and grouting the percolation was reduced to the extent of  $10^{-4}$  to  $10^{-5} \text{ cm/sec.}$  However, as the basin is small and the demand of water is high it was decided to adopt gunniting and sodium silicate treatment to treat the basin to prevent percolation. The streams were treated by gunniting to a considerable distance from the reservoir area.

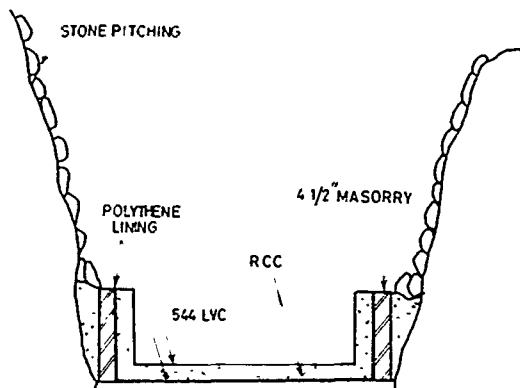
Fig. 12 Cross Section Showing Lining.

Waste weir was lined with bricks and was properly plastered. Polythene sheets were used below and around the brick lining to prevent water from percolating. The gap between the brick lining and undulated surface of the blasted waste weir wall was filled up with soil. See Fig. 11, Fig.12, Fig.13 and Fig.14.

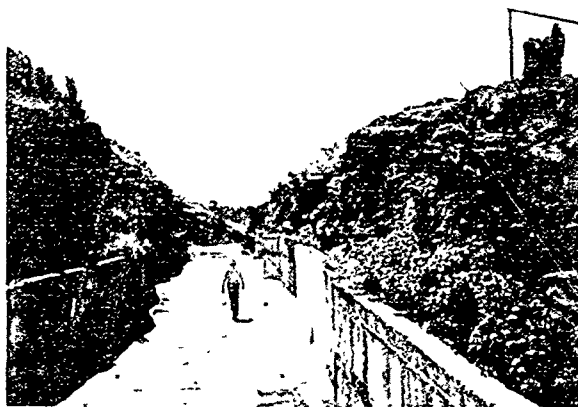
Fig. 13 View of Waste Weir After Lining.

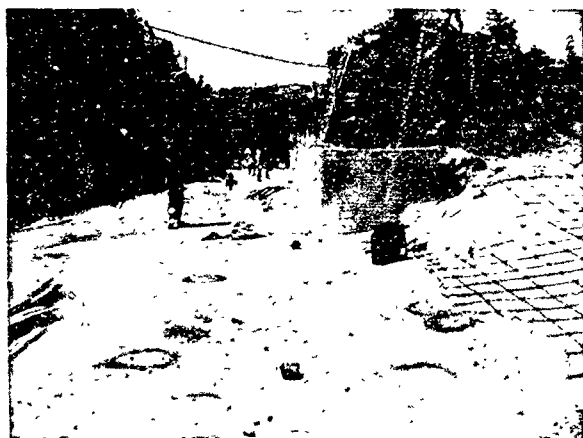
Fig. 14 Pointing of the Dam Rip Rap and Gunniting.

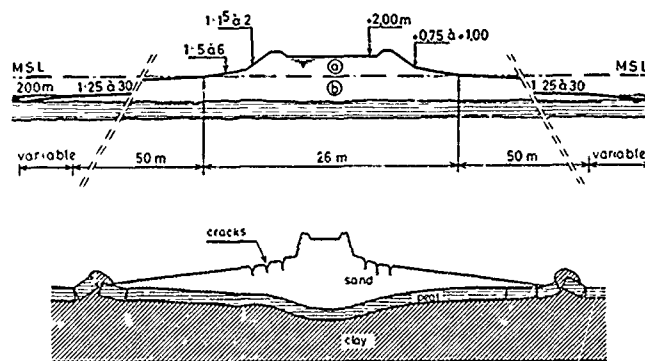
During the construction of the Markiezaatsdam failures occurred when the crest level was raised up to MSL + 2.00 m. The geometry shortly before failure is given in fig. 2a. The dam failed by subsidence of the crest, whilst the adjacent sill slightly rose. Before failure

cracks developed at the surface of the sand sill, which widened after the failure. The cracks were parallel to the length axis of the dam. About 4 or 5 days after the first instability a dark strip of blue soft clay could be seen on the edge of the sand sill (fig. 2b).

Figure 2. a. Designed cross section of the Markiezaatskade  
b. Observed deformations

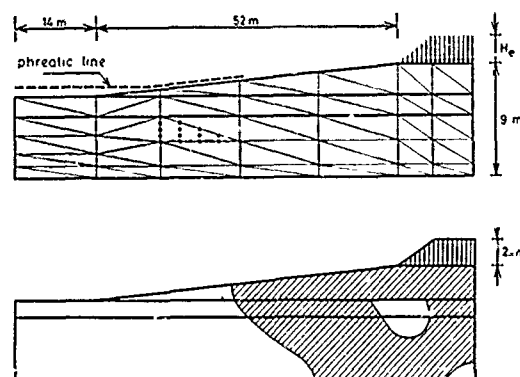
The observed failures have been analysed applying a probabilistic stability approach and an elasto-plastic FEM analysis of deformations, i.e. the PLAXIS code (De Borst & Vermeer, 1984). The geometry and water levels applied in the calculations are given in figure 3. The soil properties are summarized in table I.

Figure 3. a. Geometry applied in probabilistic stability and FEM analyses

b. Plastic zone found in FEM analysis

The zone with critical slip circles corresponds with the plastic zone, found in the FEM analysis (Termaat et al, 1985)

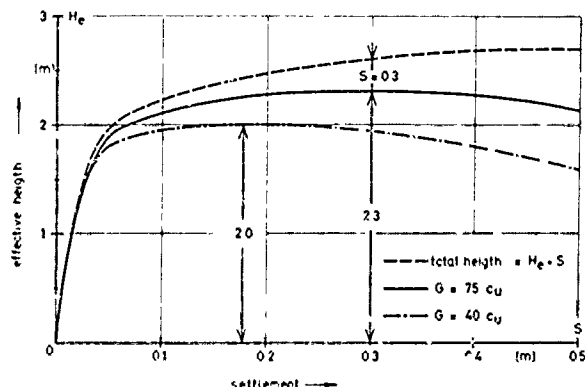
Figure 4. Effective surcharge height vs settlement

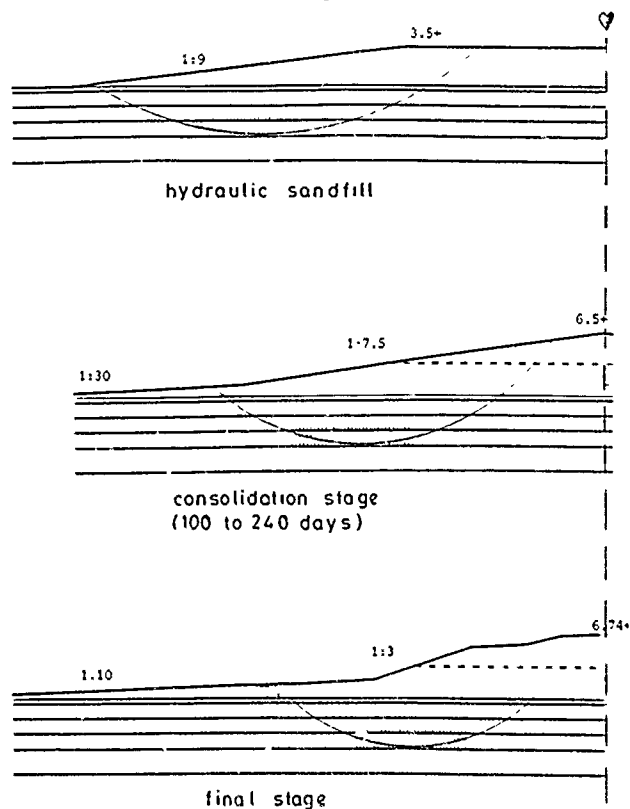
A three stage construction plan has been designed, roughly as indicated in figure 6. The stages will be referred to as the hydraulic sanfill stage (0-50 days), the intermediate preloading or consolidation stage (50-230 days) and the stage of final completion.

Figure 6. Envisaged construction stages of Oesterdam

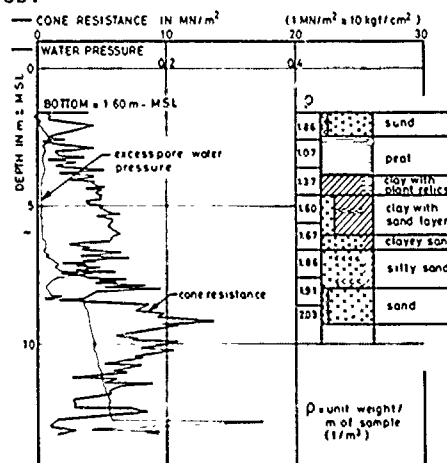
Figure 8. Results of piezo cone test and soil profile from continuous sampling.

A continuous sample profile is given in figure 8, together with the piezo cone measurement results. As can be seen excess pore water pressures indicate the impermeable layers. The results of the sensitive CPT's and the unremoulded shear strengths determined from the vane tests are given in figure 9. In the mini pressuremeter test, a  $\phi$  22 mm cell, mounted on a tube is pushed into the soil. The cell membrane consists of overlapping strips. The elastic shear modulus (G) of the soil is derived from the soil's reaction to volume increase of the cell. The results are summarized in table II. The average cone resistances have been included in this table for comparison.

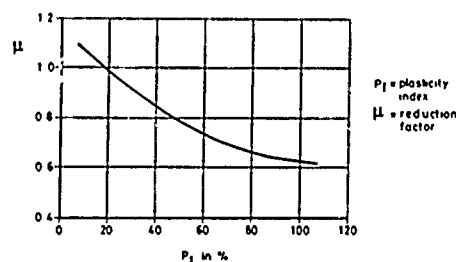
In the field vane tests only the unremoulded undrained shear strength was considered. Following Bjerrum (1972), the undrained shear strength has been reduced as function of the index of plasticity (figure 10). Unit weight ( $\gamma$ ), water content (WC), index of plasticity (PI) and results of vane tests ( $C_u$ ), with and without reduction have been given in table III.

Figure 10. Reduction of undrained shear strength

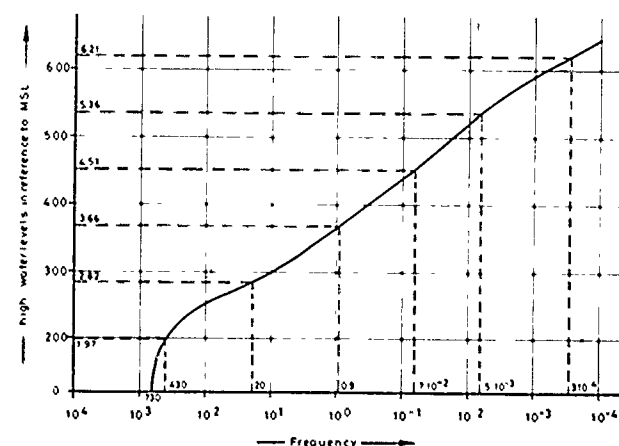
Figure 11. Observed frequencies of high tides

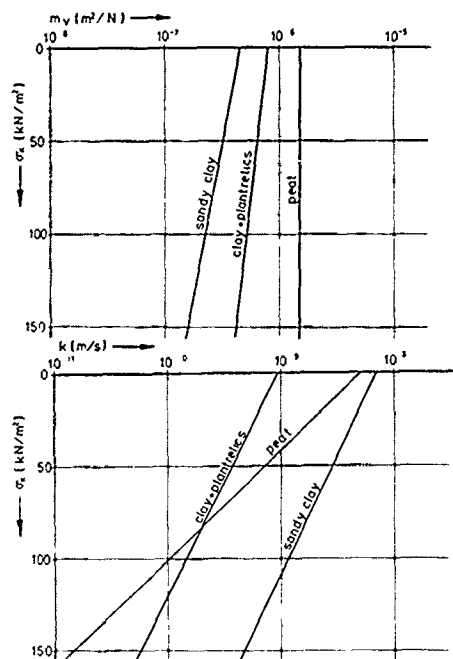
Dissipation of excess pore water pressures, induced by surcharging in the various construction stages, has been calculated on the basis of 1-D consolidation analysis. The governing soil properties are compression coefficients as function of effective soil stress (figure 12a) and permeability as function of effective soil stress (figure 12b).

Figure 12. (a) Compression coefficients ( $m_v$ )  
(b) Permeability ( $k$ )

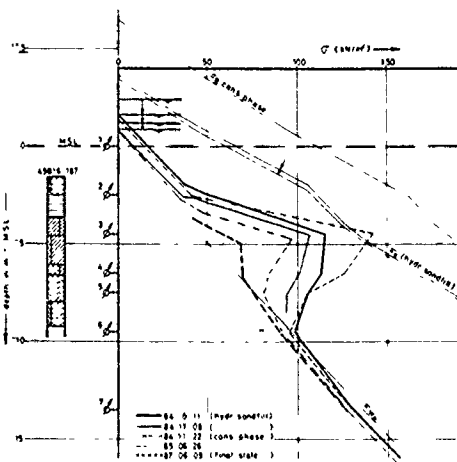
At five locations in the stretch of the dam Kistler type piezometers and settlement gauges have been installed, to monitor excess pore pressure dissipation and settlement. In the pilot section C2 seven piezometers, measuring pore water pressures in the sandfill, the deep sand and in the cohesive layers. Results of these measurements are plotted in figure 13.

Figure 13. Observed pore water pressures in dam section 2.

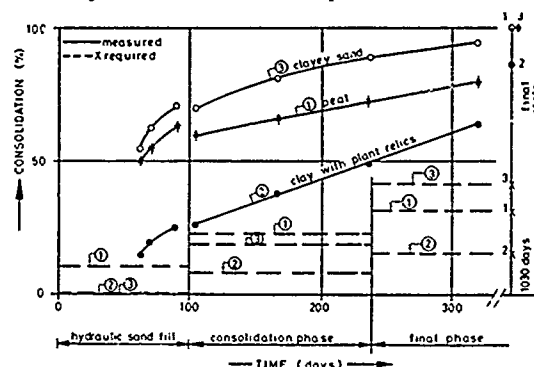
From these measurements the consolidation rates have been determined, as indicated in figure 14. It is concluded that the dissipation rates were much greater than expected, and that the envisaged consolidation stage of 130 days was substantially more than actually required.

Figure 13. Observed consolidation rates.

The observed rapid development of excess pore pressure dissipation indicates that consolidation rates have been considerably underestimated. The actual consolidation rates even exceed the optimistic ( $\mu + \sigma$ ) levels. Based on this observation the following (posterior) adjustments of the probabilities of failure could be made: for the consolidation stage  $P(f) < 10^{-6}$  and for the first 100 day period after completion  $P(f) < 3 \cdot 10^{-6}$ , based on the conditional probabilities of failure assuming ( $\mu + \sigma$ ) consolidation rates.

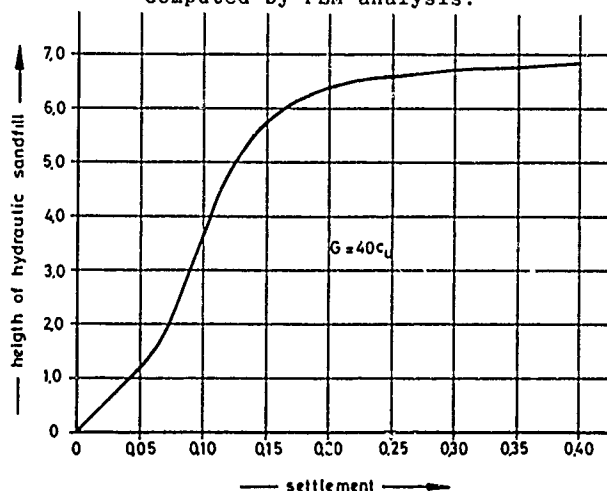
Figure 14 shows the development of zones of plastic shear when applying ultimate loading. Computed crest settlements versus surcharge are shown in figure 15, revealing an ultimate surcharge height of 7 m. The actually applied surcharge height was 4.5 m.

Figure 15. Height of sandfill vs settlement.

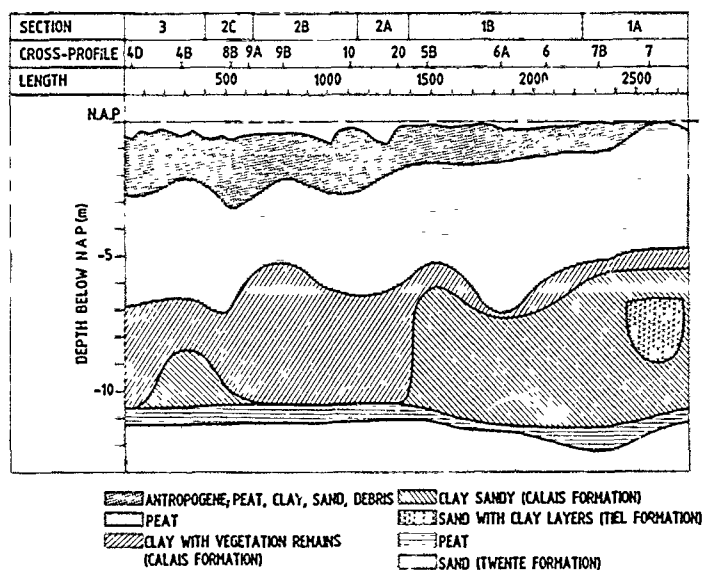
On the basis of the results of the site investigation a geological profile along the dike section is composed (Oranjewoud 1987), Figure 2.  
At a depth of 11.20 - 12.20 m below the reference level N.A.P. sand formations formed during the late-pleistocene are present above which a thin layer of peat varying between 0.3 and 0.9 m is found.  
Besides a clay layer (holocene deposits) varying in thickness between 4 and 6 m on which a 3 - 5.5 m thick layer of peat can be found. The clay layer contains relatively a high quantity sand in the lower sections and vegetation remains in the upper sections.  
The upper layer, which is in fact the dike body, strongly varies in composition and thickness: besides peat, also sand, clay and debris are present. Human activities have strongly influenced this layer.

Fig. 2 Geological profile of the dike of polder Oudendijk

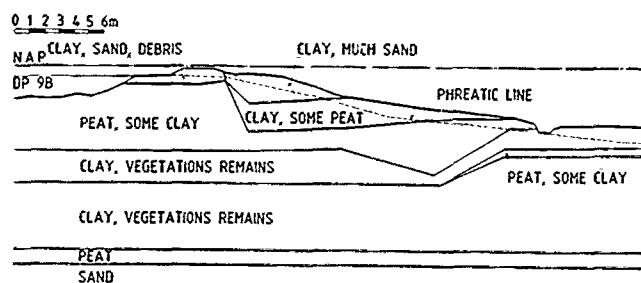
Fig. 3 Bottom schematization cross-section 9B

Not only longitudinal variation in the geological stratification is found but also perpendicular to the axis of the dike.  
An example is given in Figure 3.

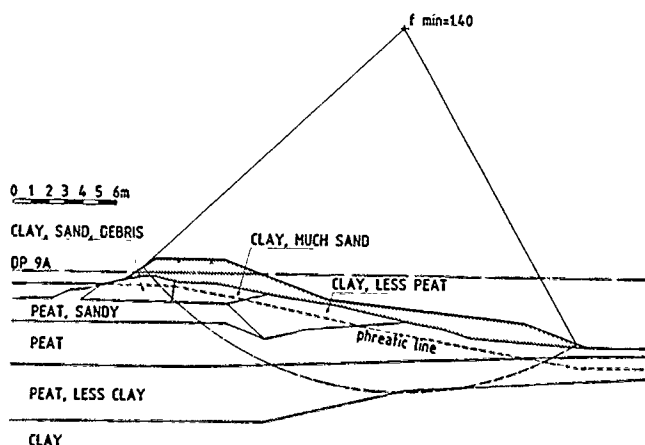
Fig. 4 Necessary replenishment and minimum slide-circle for cross-section 9a

The calculations are carried out for 11 cross-sections. Figure 4 shows an example for one section.

Over a section of 1.3 km it was necessary to excavate a part of the toe of the dike and replace it by sand. Thus not only the stability was improved but also the seepage moved from the innerslope to the toe.

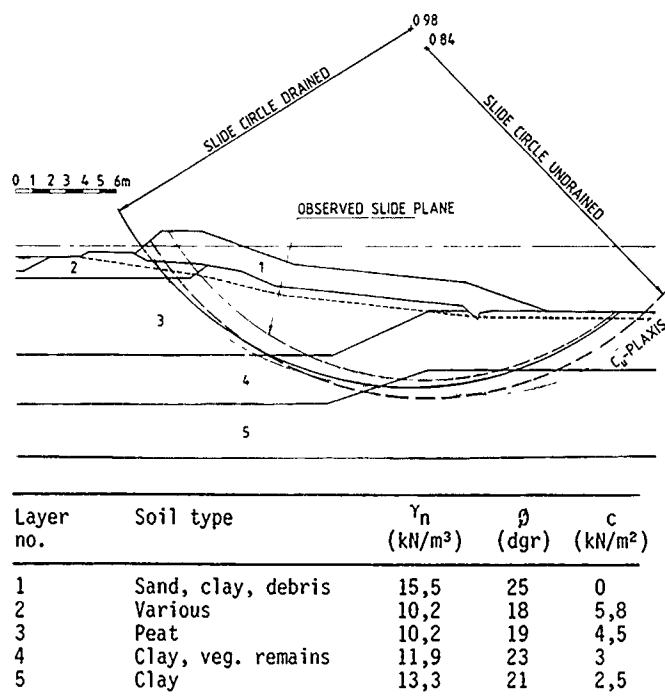
Fig. 6 Slide-circles for the second instability

Figure 6 shows the slip-circles for the second sliding observed at the spot as well as found by means of calculations.

The calculated failure circles are rather comparable, Figure 6.

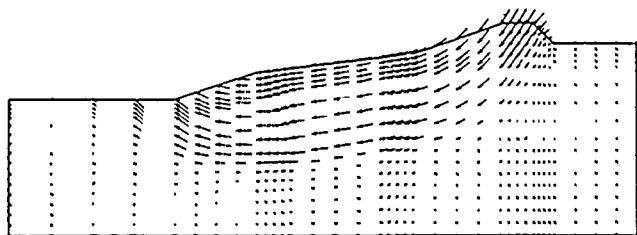
Fig. 7 Displacement increments for the second sliding

Contradictory to the slide-plane methods the critical plane in Plaxis is found as result of the calculations. Figure 7 shows the displacement increments at failure. It has to be noted that not an exact circular slide plane is found.

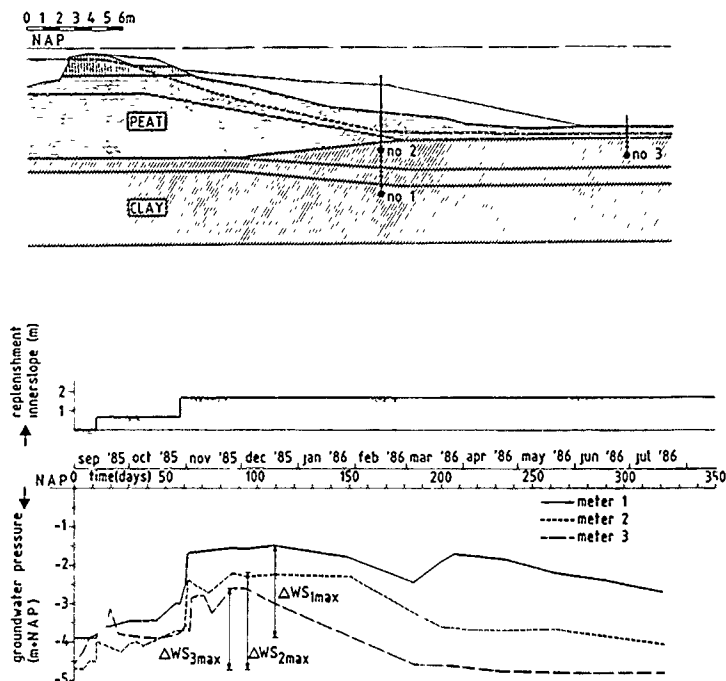
Fig. 8 Waterpressure measurements in cross-section 17a

In Figure 7 the results of measurements from waterpressuremeters in an other cross-section of the dike are given. It proved that the raise of the hydraulic pressure in the meters 1 and 2 passably corresponds with the weight of the loading; meter 3 however shows extensive pressures beyond the toe of the dike. The latter is taken into account by the  $c_u$ -method.

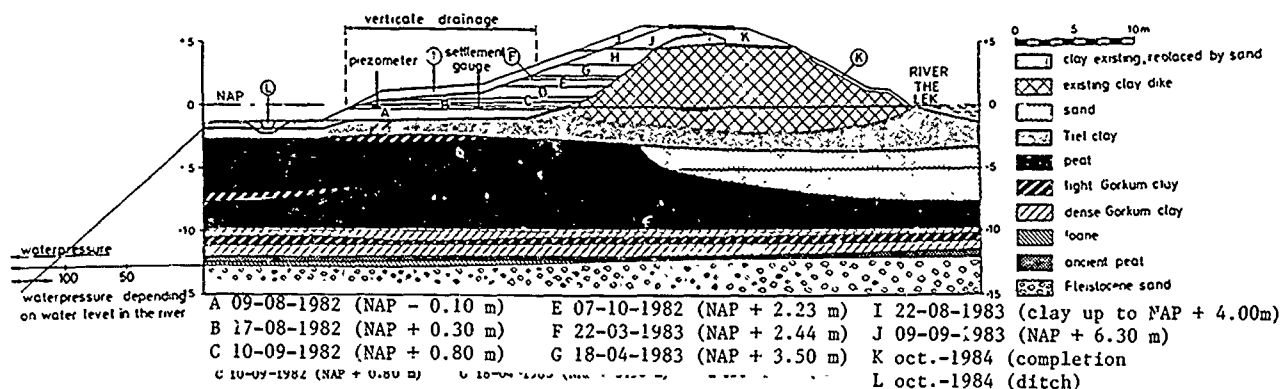
Figure 2. Geotechnical profile and fasing of the applied fill (heights related to NAP)

In order to shorten the consolidation period vertical drainage is applied under the berm. The type of the applied drains is Colbond KF 650 reaching up to approximately 1.5 m above the aquifer which is found at the level of NAP (New Amsterdam datum) -12.5 m. After the first working season the embankment reinforcement was raised up to NAP + 2.30 m. After the winter period the construction resumed in March 1983. In September 1983 the top level, NAP + 6.30 m, of the embankment was reached. The clay cover was brought up in August/September, 1983. The completion of the outer slope was carried out from August up to the end of September.

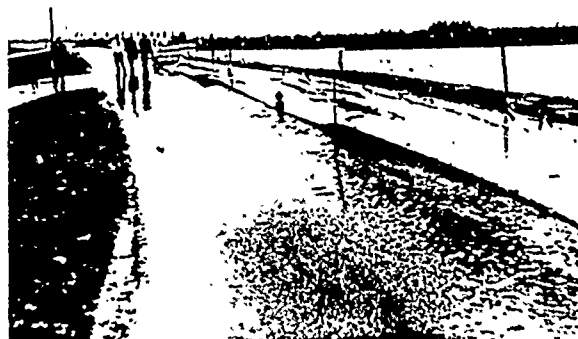
Fig. 3. Deformation of the road surface on 22 October at 10.00 hrs.

Early next morning (22 October) a maximum height difference of 20 cm was measured in the road surface (Figure 3). The settlement increased extensively during the day (approx. 3 cm per hour). The horizontal ground movements in the hindlying polder started to cause problems at the various houses. Around high tide the deformation/velocity seemed to be higher than at low tide.

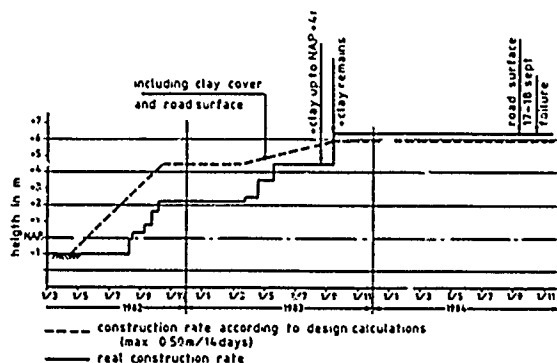
Fig. 4. Construction rate versus construction rate according to design calculations

Just as figure 2, figure 4 indicates the times on which the various activities concerning ground work have been executed. These times are compared with the assumed loading rate in the design calculations.

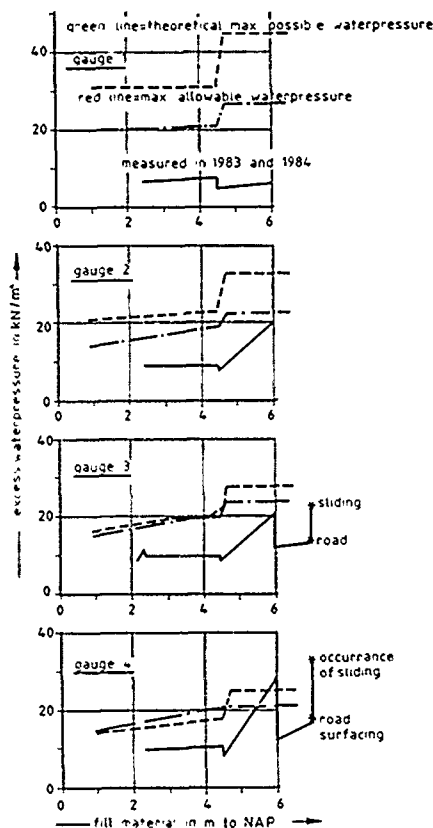
Fig. 6. Measured and allowable waterpressures 1984

Initially the embankment was raised at a substantial rate. By May three raising steps (totally about 2 m sand) were completed. The raisings, introduced none or hardly any increase of the water pressures (figure 5). According to the "red lines" (figure 6) no equilibrium problems were expected at this stage. After several months of rest great activity was employed around September (figure 4). In two weeks time a 0.70 m clay cover was positioned on the berm and the lower part of the slope, the sand body was raised from NAP + 4.50 m to NAP + 6.30 m and the upper part of the slope was covered with a 0.70 m clay layer. In fact this action meant the realization of the complete reinforcement with the exception of the finishing of the outer slope and the raising of a strip outside the reinforcement, directly above the former road. Consequently the loading stages through these last raisings in September the excess pressures increased much more than theoretically could be expected (see the "green line" in figure 6). The deepest gauge indicated even more than was allowed according to the "red line". High excess pressures and the end of working season implied the postponement of further activities.

At the start of the activities in 1984 the waterpressures had decreased significantly with respect to the measurements in November 1983 (figure 5 and 6).

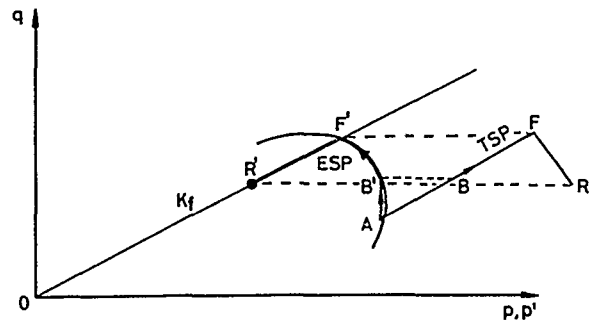
Fig. 7. Induction of excess pore pressure

Initially, there is an elastic behaviour for  $OCR > 1$ . The increase of water pressure  $\Delta u^e$  is caused solely by an increased total isotropic stress. For plane strain and undrained behaviour (Poisson ratio  $\nu = 0.5$ ), this can be approximated by (effective stress path A'B and total stress path A'R on figure 7).

After having developed a normally consolidated behaviour, either by consolidation (effective stress increase) or by shear stress increase, an increase of shear stress will also cause an increase of pore water pressure ( $\Delta u^s$ ). For plane strain conditions and undrained behaviour, this water pressure increase (which is a function of the increase of the octahedral shear stress  $\Delta \tau_{oct}$ ) can be written as (ESP B'-F' and TSP B-F on fig. 7).

When the applied shear stress in the foundation layers somewhere equals the shear resistance, locally no further shear stress increase can occur (point F' and F on fig. 7). In this failed areas, local plastic flow will lead to a further increase of pore water pressure ( $\Delta u^p$ ) in comparison to the elastic solution. Indeed, at failure, the difference between the principal stresses  $\sigma_1$  and  $\sigma_3$  is equal to twice the undrained strength  $C_u$  at the moment of loading:

Local plastic flow and the subsequent stress transfer in the plastic area, will affect the stress increases distribution in the nearby non-failed area (Bauduin, 1987), which become higher than resumed from an elastic solution. This phenomenon is comparable with the force redistribution in a hyperstatic steel beam when yielding is reached. Finite element calculations with elasto-plastic material behaviour enables the stress transfer to be calculated without restrictive assumptions. Sensitive clays show a sudden reduction in strength upon reaching the failure surface. As the effective stress path has to remain on the failure surface (Tavenas, 1977), this will cause a sudden increase of pore water pressure (ESP F'-R' and TSP F-R on fig. 7).

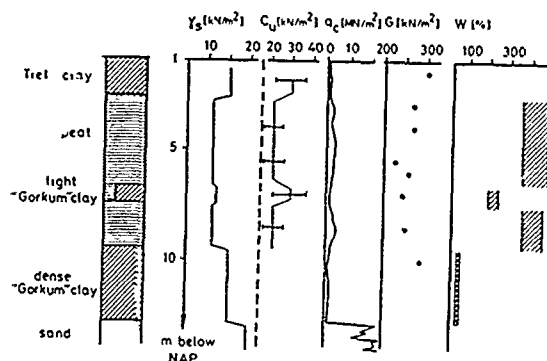
Fig. 8. Bore log and results of in situ soil investigation at the toe of the dike

The calculation parameters have been evaluated from laboratory and in situ tests (see fig. 8 and table 1).

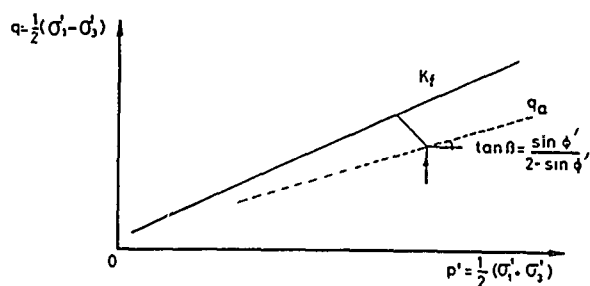
Fig. 9. Simplified material model as used for the calculations

A much simplified pore pressure induction model was used to simulate the yield surface (see figure 9). The choice of this model is based on the results of earlier CIU and CAU triaxial tests on young peat and soft clay in the Netherlands (Beetstra, 1978) and the YLIGHT model presented by Tavenas (1978). The permeability of the soil layers in vertical ( $k_v$ ) and horizontal ( $k_h$ ) directions were measured by laboratory tests. They appeared to be stress and direction dependent the results for the peat showed scatter. The coefficient of horizontal stress at rest ( $k_0$ ) has been taken approximately 0.6 for the clay and 0.5 for the peat.

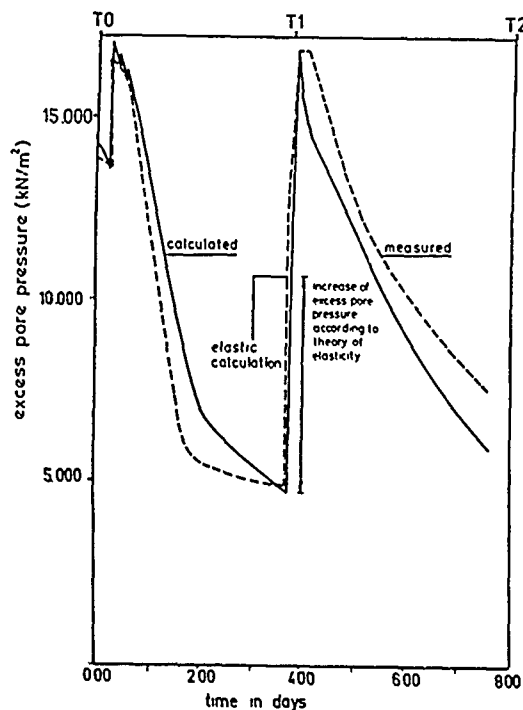
Fig. 11. Measured and calculated excess pore pressure at the toe of the dike (8.1 m below NAP) gauge 3.

With the added effects of plastic flow and shear stress, a better correspondence between calculated and measured pore pressure is obtained. However, for the deepest piezometer, the measured value remains higher. Reasons for this can be an underestimate of the effects of a shear stress increment, strain softening or lack of accuracy in measurement or calculation. The measured time for  $\Delta u$  does not appear clearly from the calculations and could be a consequence of a delay in plastic stress transfer. Figure 11c show the area of maximal mobilized shear strength. The extend of this area, as well as the results of a sensitivity analysis of the undrained shear strength at  $t_1$ , indicated an almost complete loss of strength reserve during this loading stage.

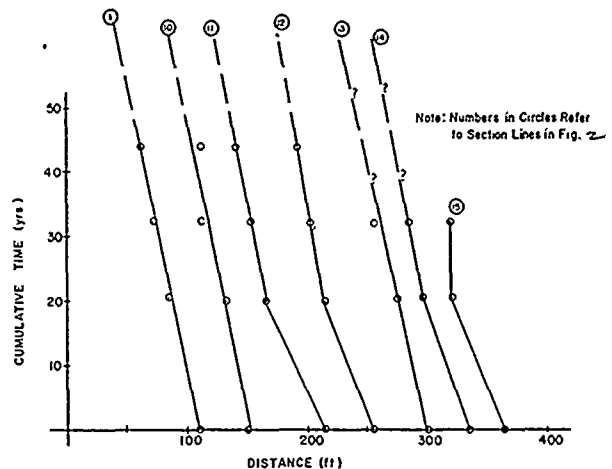
Fig. 2a Distance From Fixed Point To Coastal Bluff Versus Time

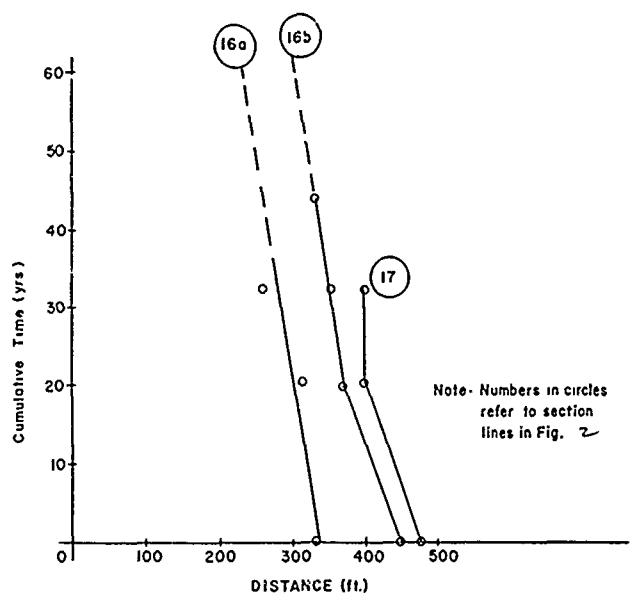
Fig. 2b Distance From Fixed Point To Coastal Bluff Versus Time

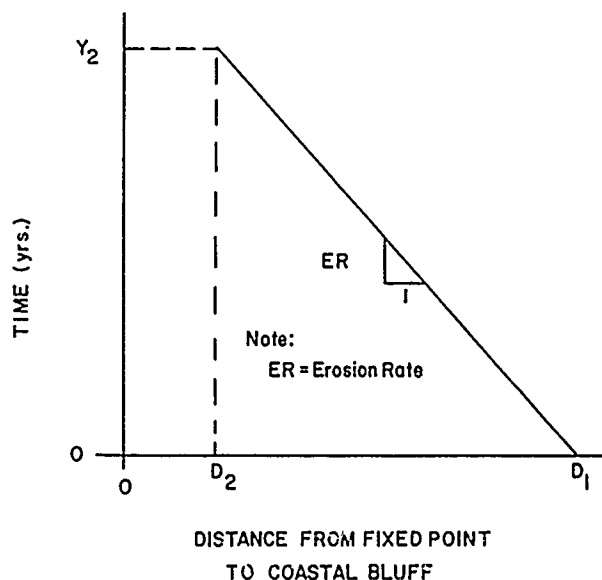
Fig. 3 Schematic Illustration of Distance from Fixed Point to Coastal Bluff Versus Time

The erosion rate (ER) is defined as the change in distance from a known point to the edge of the coastal bluffs as a function of time as shown in Figure 3 and as given in equation 1.

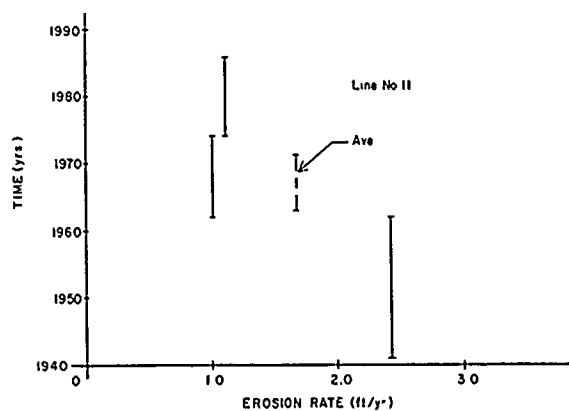
Fig. 4 Erosion Rate Versus Time, Line No. 11

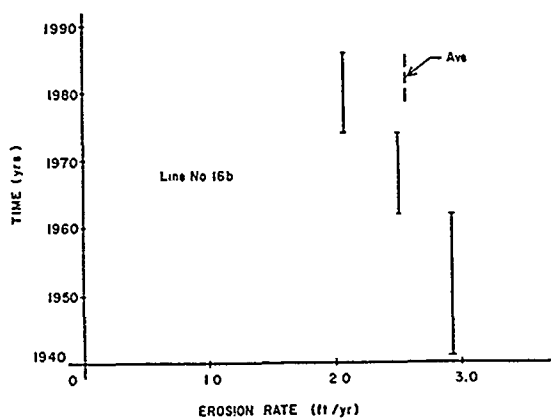
Fig. 5 Erosion Rate Versus Time, Line No. 16b

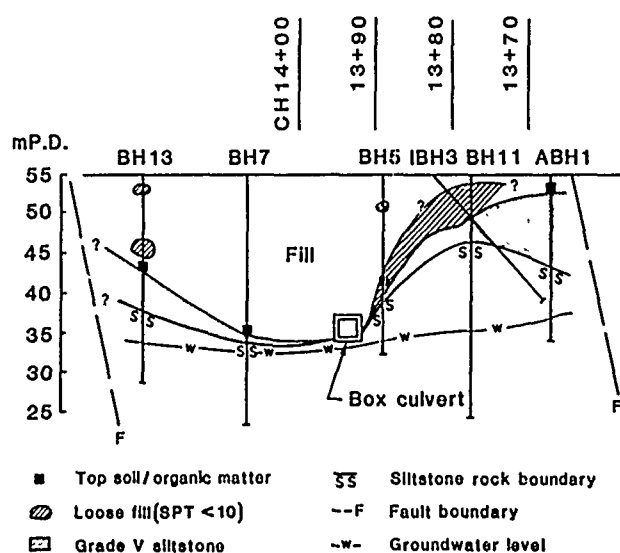
Figure 1 - Cross section through trunk road showing the geological and groundwater conditions

data and records of emergency measures were scrutinised. Aerial photograph interpretation and field geological mapping were carried out. Trial pits, inspection trenches, GCO probings (GCO, 1987), drillholes and piezometers were ordered to assess the geological and ground-water conditions and the density of the fill. Air foam was used as the flushing medium for the drillholes that were sunk through the embankment body, to minimize the possibility of any adverse effects on the stability of the side slopes (Phillipson & Chipp, 1981; 1982). Drilling was closely supervised. Standard penetration tests carried out in the drillholes revealed the presence of a patch of loose material above the eastern valley face (Figure 1).

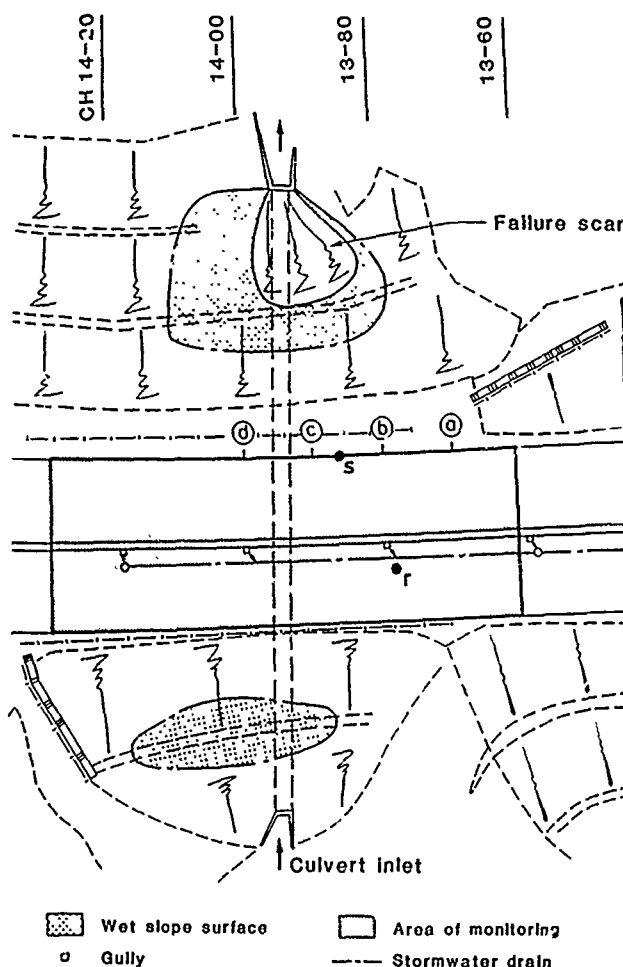
Figure 2 - Plan showing area of road surface monitored

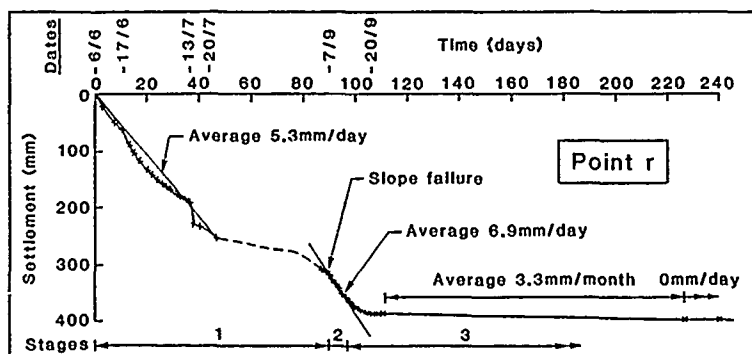
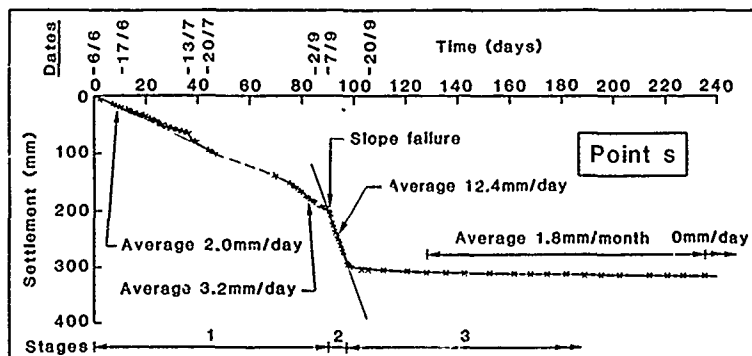
Figure 3 - Settlement histories of points r and s with summary of events

(a) Settlement-time Relationship for Point r

(b) Settlement-time Relationship for Point s

- (a) Stage 1 settlements had a dish-shape and appeared to have resulted from a point disturbance around point r (Figure 5). They had a stick-slip relationship with time (Figure 3a), i.e. a 'collapse' type of settlement. Calculations indicated that the 20 kPa test load could have induced up to about 10% of the total settlements in this stage.

- (b) Stage 2 settlements were much more rapid (Figure 3b) and were likely to be related to slope instability (Figure 6). Stability analyses of the side slopes assuming 'dry' condition, i.e. zero pore pressures, gave factors of safety in excess of 1.2. However, measurements taken in the grout holes after drilling indicated high water levels in the holes. In one of the holes, water was found to be only 5 m below the road surface. Further stability calculations using the measured 'phreatic surface' revealed factors of safety close to unity. There was heavy rainfall between 4th and 6th September. The rain could have had some effects on the slope, but it could not be the main cause of failure as the slope had survived previously harsher rainstorms.

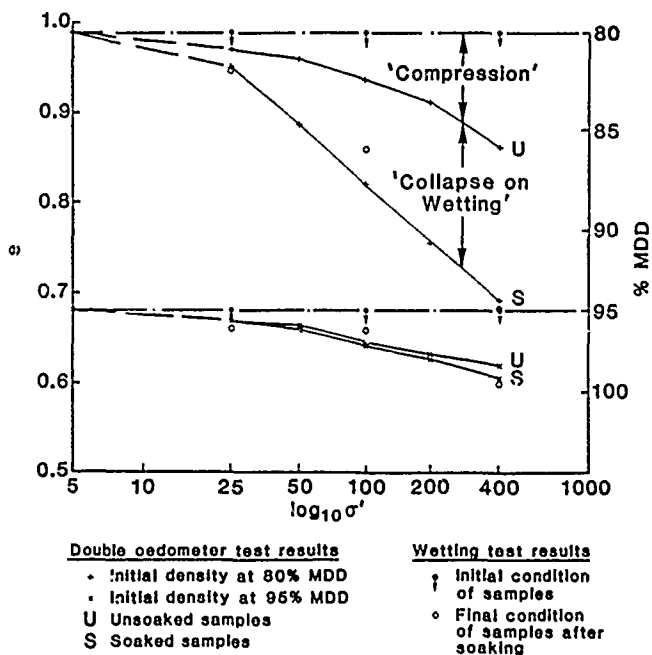
Figure 4 - Results of oedometer tests

The results of these tests are summarized in Figure 4. It can be seen that there are two components of settlement, viz compression of the unsaturated material, and collapse due to wetting.

A series of oedometer tests were also performed to investigate the compressibility characteristics and collapse potential of the fill. The test specimens, which were 75 mm diameter by 19 mm thick, were prepared from samples remolded at optimum moisture content. Two types of tests were carried out :
